LIGHT INDUSTRIAL CASE STUDY

MOWER DECK

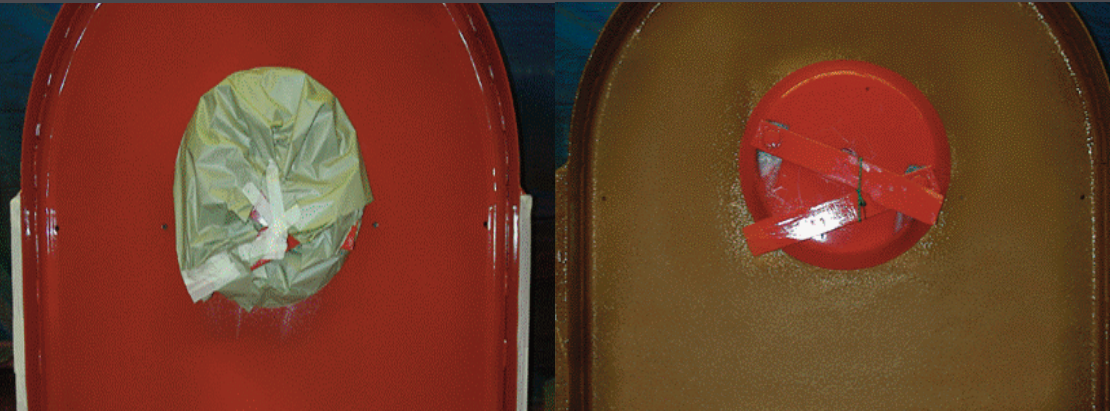
LINE-X XS-350 a pure polyurea was applied to the underside of the mower deck following it being etched and primed.

After more than four years of rigorous use in an agricultural environment, LINE-X XS-350 remains virtually intact. No rust. No corrosion. No repairs or replacements required. In addition, the LINE-X coating helped prevent the buildup of grass and other debris on the underside of the deck. It also provided a noticeable noise reduction since the coating decreases the resonance of metal surfaces.
